Underwood & Ward
Facility & Enrollment Study
Existing Facilities Assessment

June 13, 2023

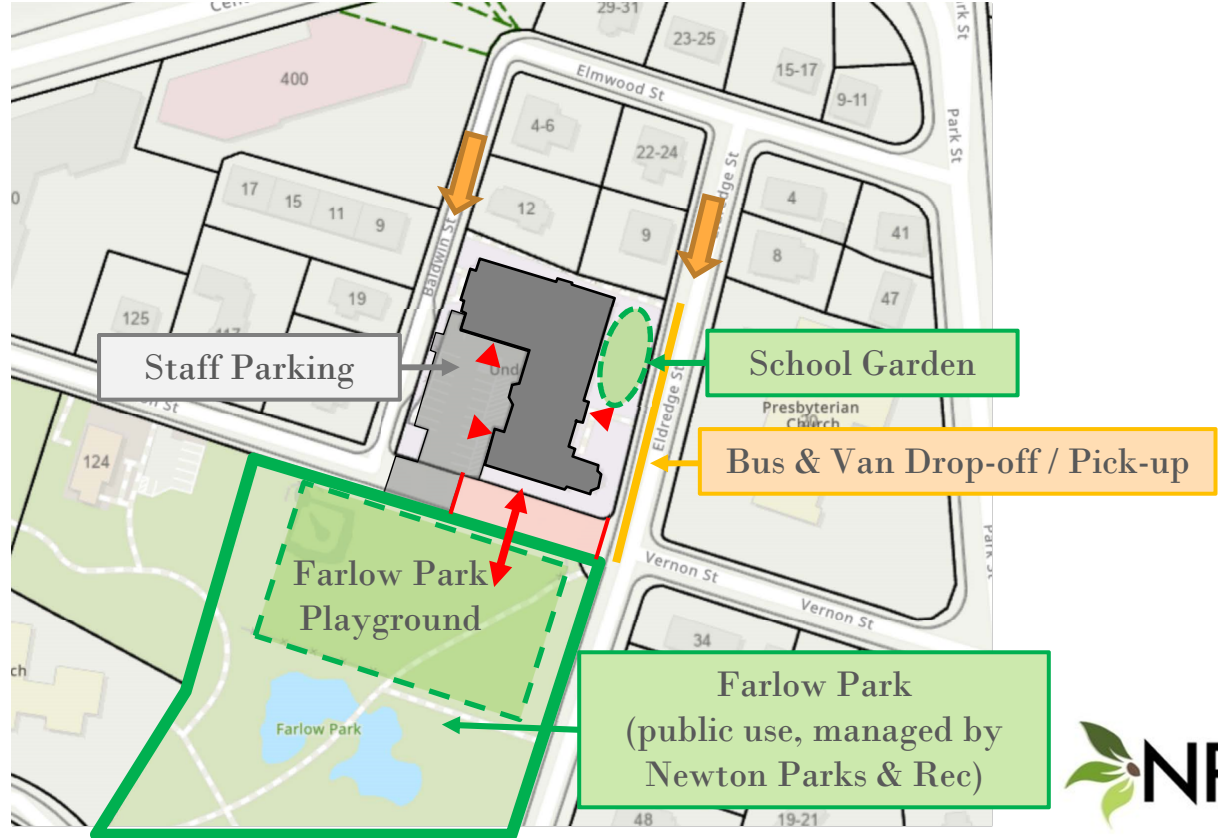
Original 1924 site plan

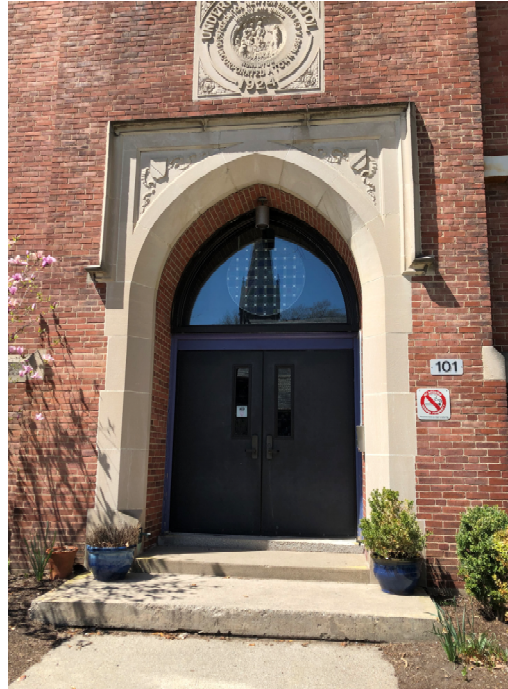
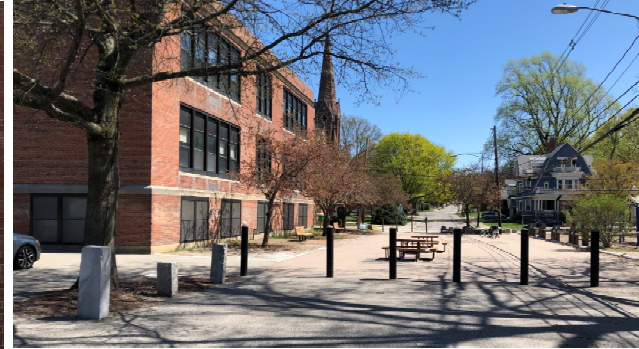
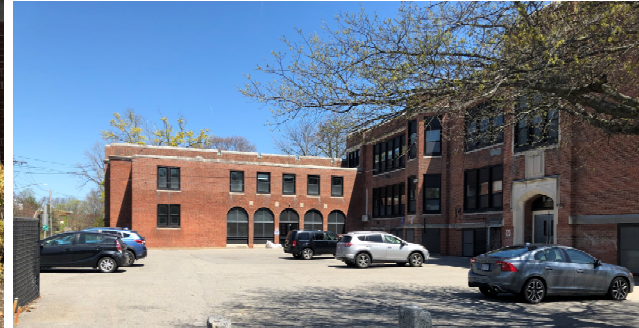
Underwood Elementary Site Context & Access

- 1 acre site, building footprint is $\frac{3}{4}$ of site, parking about $\frac{1}{4}$
- Located within NRHP Farlow & Kenrick Park Historic District
- School does not have dedicated play space, shares Farlow Park playground with public
- Part of Vernon Street permanently closed for easier access, additional parking
- Main entrance on Eldredge St

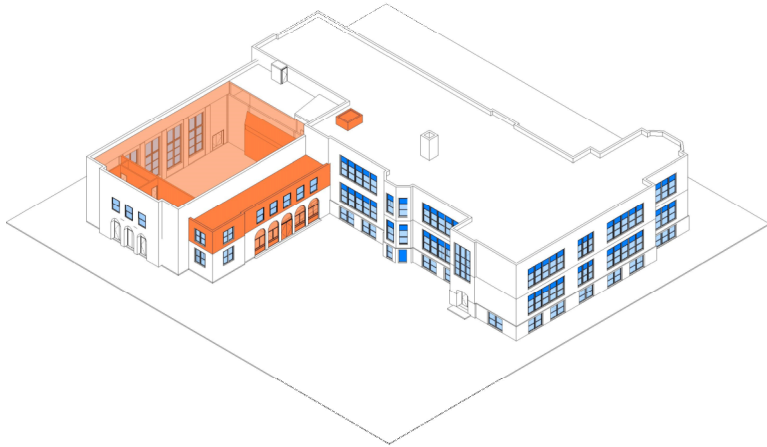
Underwood Elementary Building Evolution

School opens, features assembly hall, boys & girls playrooms in basement, coal storage rooms

New cafeteria, art and music classrooms in basement
Assembly hall/gym partitioned, stage converted to library
Assembly hall loggia enclosed to create new lobby
New toilet rooms
New elevator replaces part of stairwell
Office mezzanine added above gym and lobby

Exterior window replacement

Nurse suite reconfigured for Covid

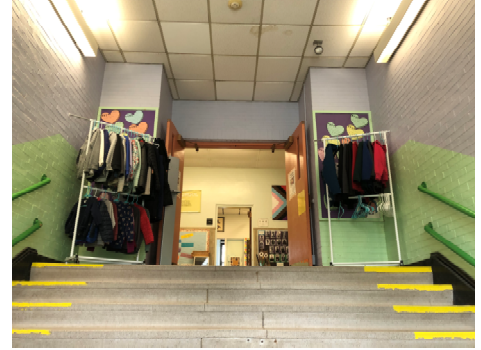
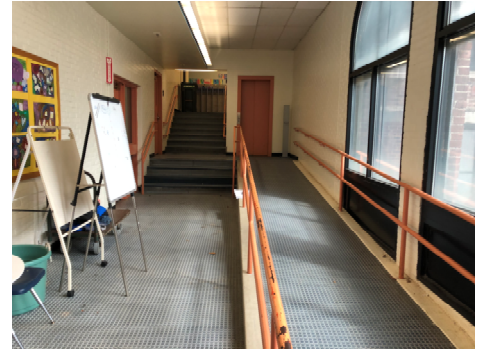
Underwood Elementary

- 1 accessible building entrance at grade, remote from main office
- Granite steps, interior stairs are barriers for other entrances/exits
- Ramp handrails are not 521 CMR compliant, landings are smaller than 5 feet in some areas, clear width narrower than 4 feet at library
- Elevator is small and does not accommodate a stretcher
- Certain floors cannot be reached by wheelchair (library, music loft)
- Boys & girls toilet rooms have floor level challenges and raised platforms at stalls; staff toilet rooms do not meet minimum room size for turning radius, do not have accessible fixtures
- Push/pull side clearance conflicts observed at multiple doors, size of some door leaves less than 3 feet
- Casework does not allow knee space at sinks

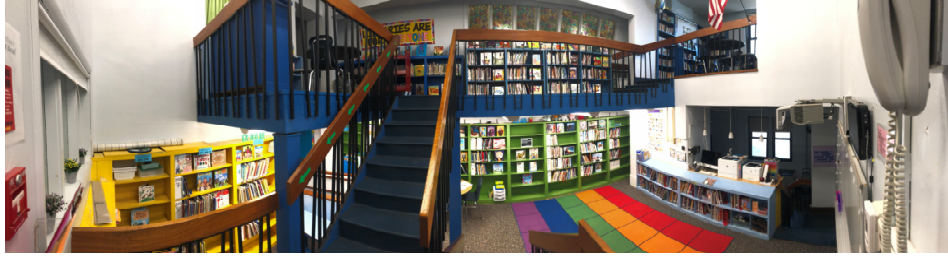
Library section

- Level 7
- Level 6
- Level 5
- Level 4
- Level 3
- Level 2
- Level 1

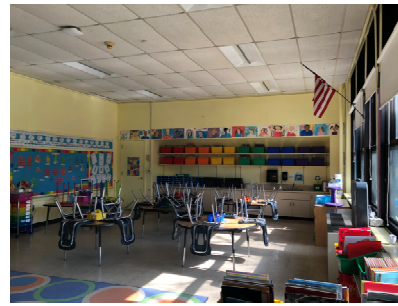
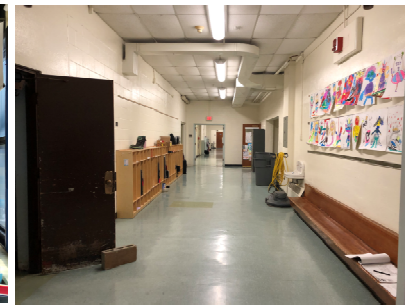
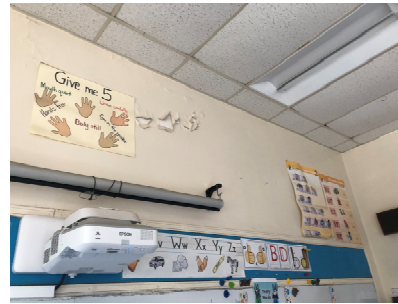
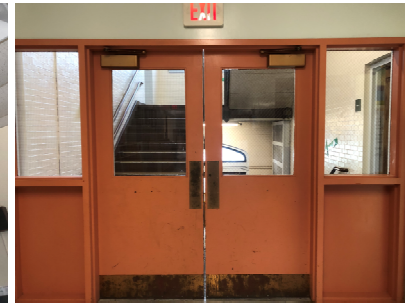
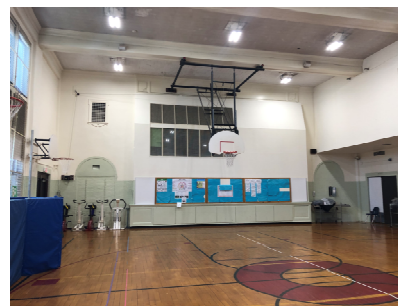
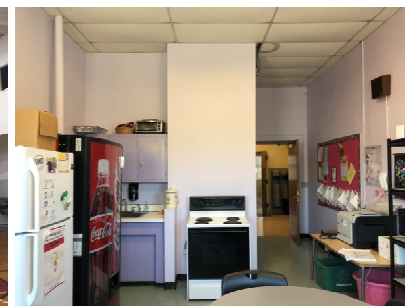
Underwood Elementary Interior Finishes & Assemblies

- Floor, wall, and ceiling finishes at end of life
- Casework original to 1978 renovation, not accessible
- Water damage from roof leaks, floor/ceiling in gym damaged
- Signs of rust on stair finishes and under carriages
- Fire-ratings undefined, wire-glass no longer accepted by code as fire-rating
- Appliances and fixtures are dated
- Guardrails are only 36" at stairs, library, loft

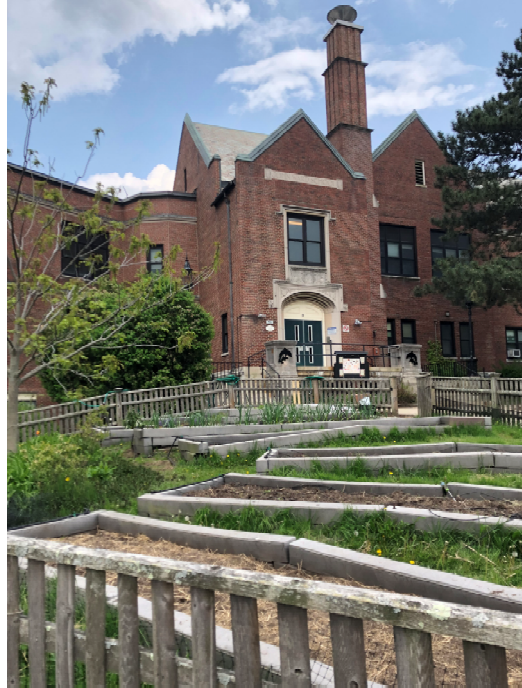
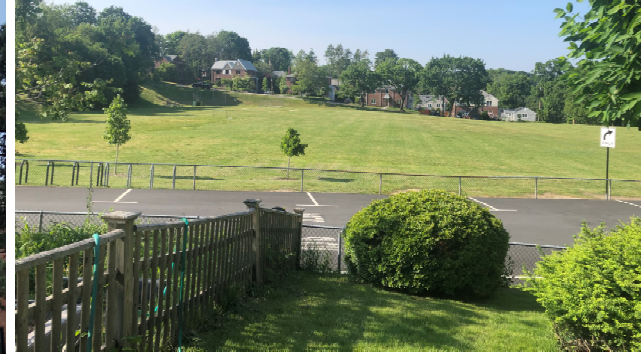
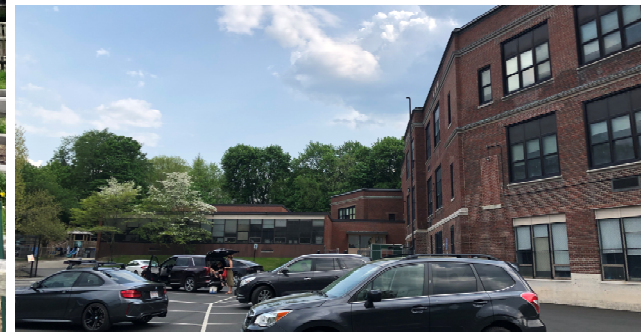
Ward Elementary Site Context

- 3 acre hillside site, with 3.5 acre public use Ward Park to north
- School has dedicated playground and tennis courts, both are maintained by Newton Parks & Rec, controlled by NPS
- Main entrance on Dolphin Road, one way street in residential neighborhood
- Easements at the edge of property, ROW within park

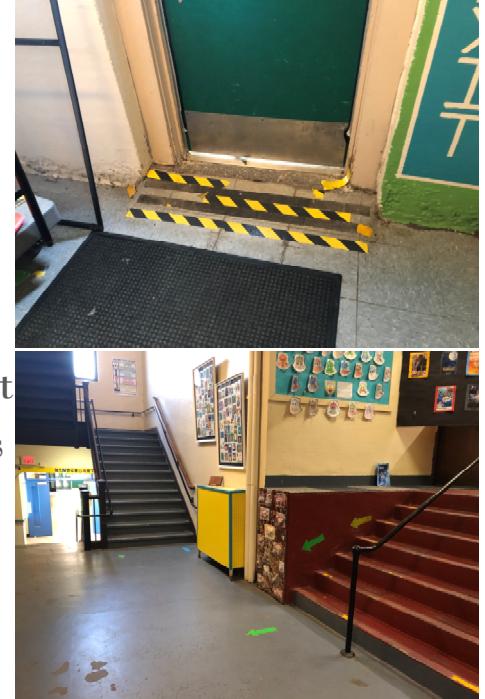
Ward Elementary Accessibility

- 1 accessible building entrance at grade near gym, remote from main office, 1 building entrance at grade in basement, but threshold is steep
- Site walkway from parking to playground appears steeper than 1:20
- Granite stairs, interior stairs are barriers for other entrances/exits
- There is no elevator - first, second, and library floors are inaccessible
- Boys & girls toilet rooms have floor level challenges and raised platforms at stalls, no accessible stalls in some; staff toilet rooms do not meet minimum room size for turning radius, or have accessible fixtures
- Floor level changes at the library and staff lounge
- Push/pull side clearance conflicts observed at multiple doors, size of some door leaves less than 3 feet
- Casework does not allow knee space at sinks

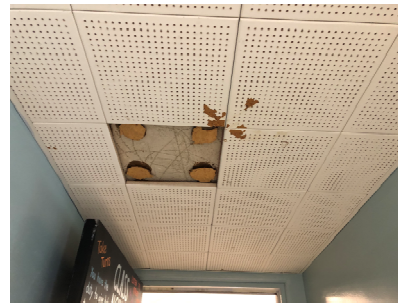
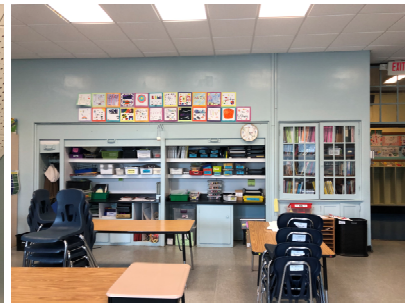
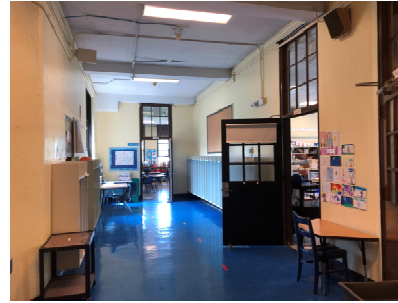
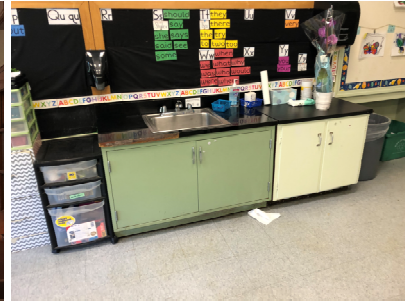
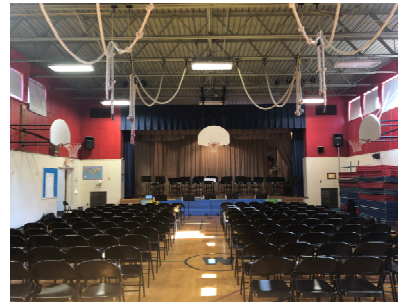
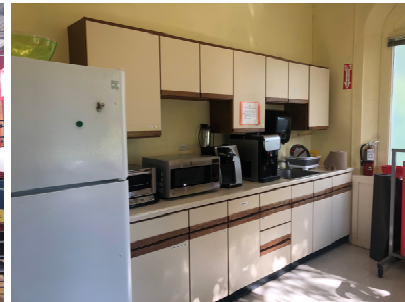
Ward Elementary Interior Finishes & Assemblies

- Floor, wall, and ceiling finishes at end of life (some ceilings/lighting have been replaced in the last few years)
- Water damage from roof leaks
- Most built in casework is original, hardware not operable, other casework not accessible
- Signs of rust on stair finishes and under carriages
- Fire-rated shafts at stairs not defined, wire-glass no longer accepted by code as fire-rating
- Appliances and fixtures are dated
- Guardrails are only 36" at stairs
